CONTEXT-SENSITIVE DESIGN CASE STUDY NO. 2

Merritt Parkway – Greenwich, Connecticut

PROJECT DESCRIPTION AND HISTORY:

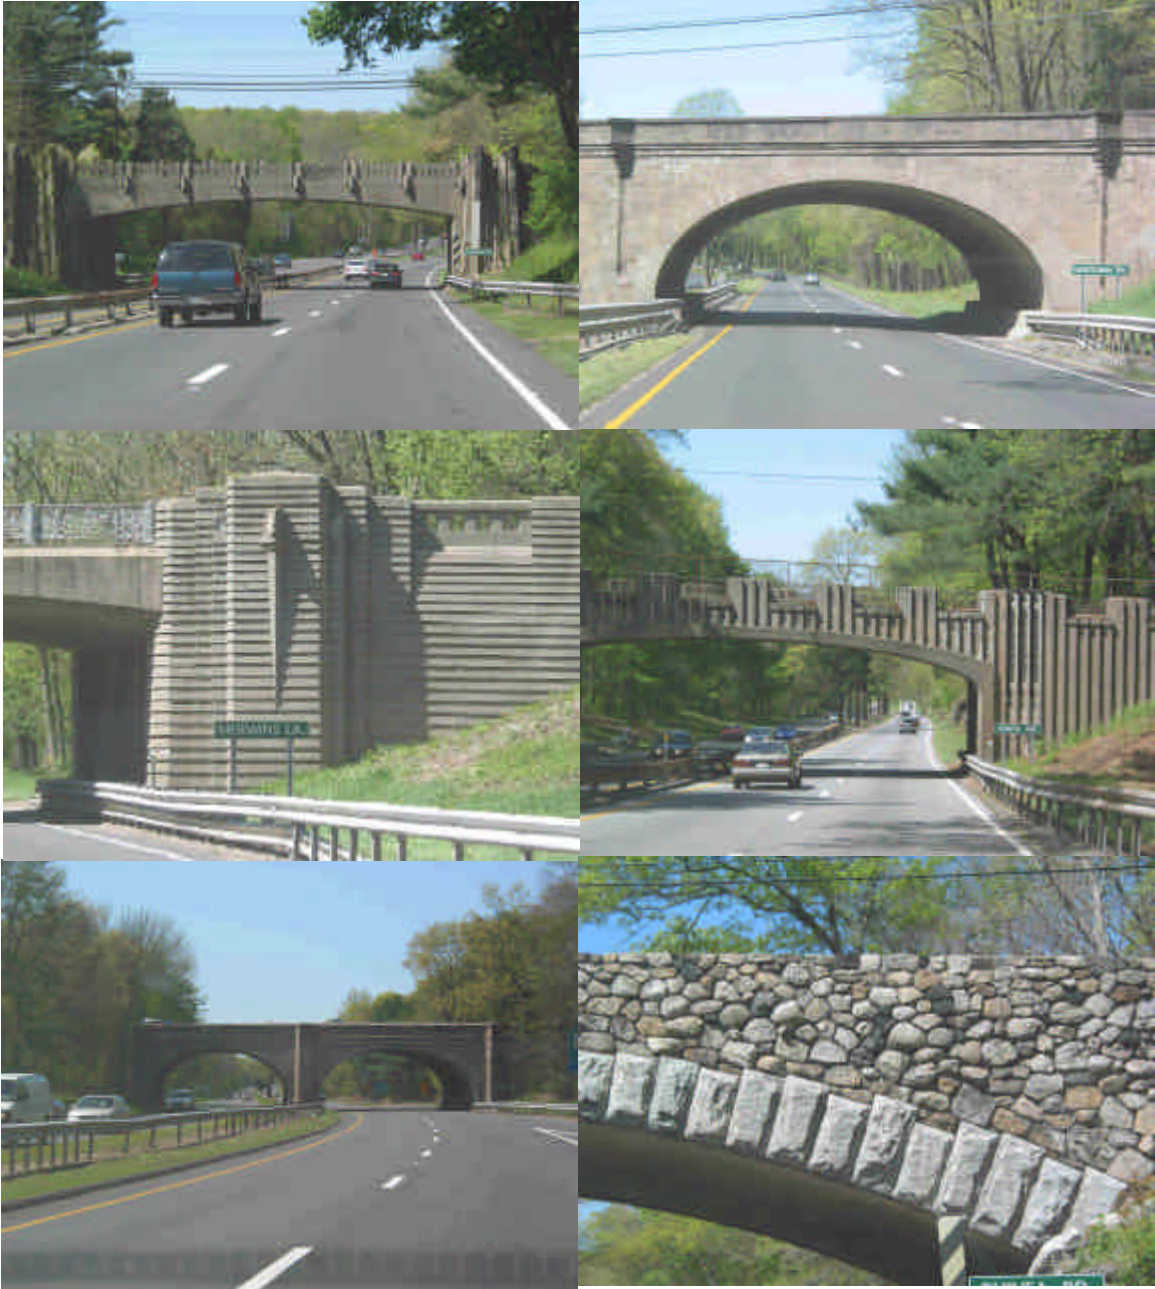
Figure 2: A Selection of Bridges on the Merritt Parkway

The most notable aesthetic features of the parkway are the bridges representing Art Moderne, Art Deco, Classical, Gothic and Renaissance architecture. These bridges are undoubtedly the most treasured aspect of the facility for the community and travelers alike (See Figure 2). Each bridge, both over and under the parkway, is unique and very few had been replaced or altered significantly for maintenance or

The guidelines for the Merritt Parkway also include provisions that ensure restoration of the bridges will proceed in a manner that protects their unique character. This includes the eventuality where a complete bridge might need replacing. In that event, the original design will be replicated. Any new bridge over the Merritt Parkway must also be in line with the prevailing

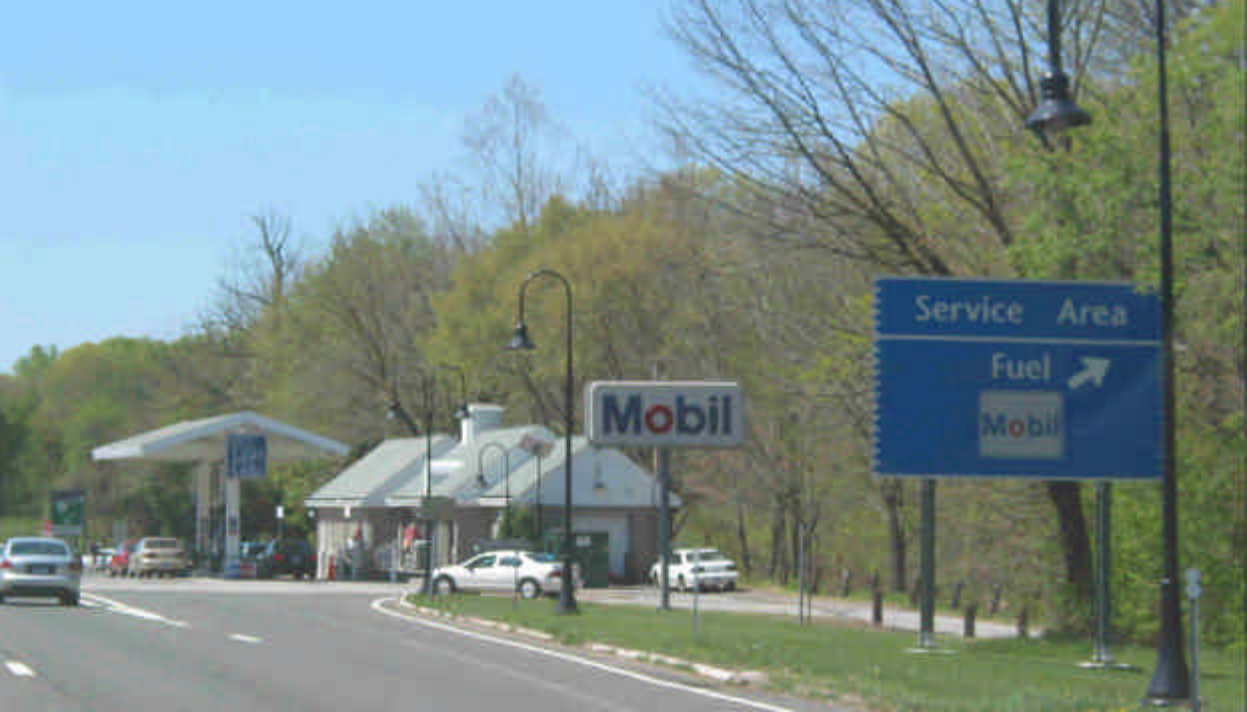
Figure 3: Merritt Parkway Service Center

repair. A less unique, but certainly charming, architectural element to the parkway is the frequent service areas which consist of miniature stone “old fashioned” gas stations (Figure 3).

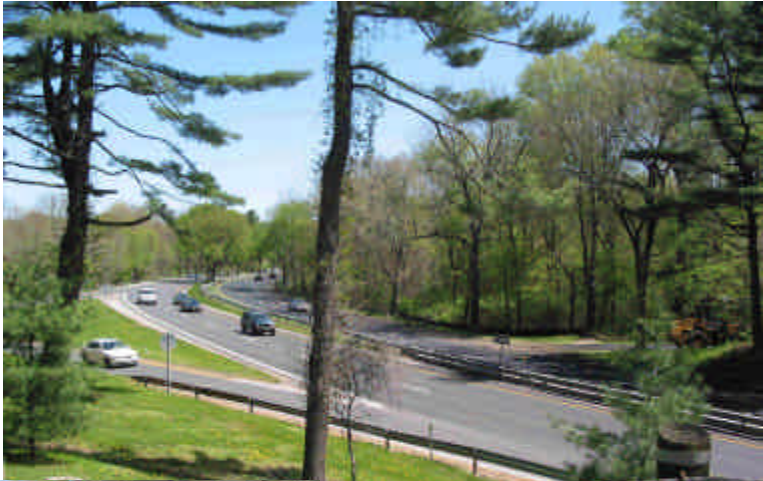
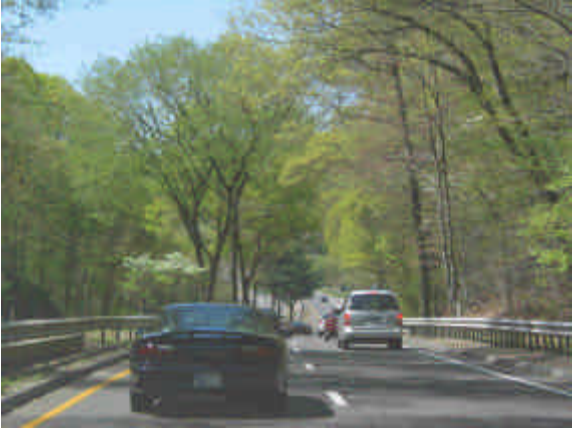
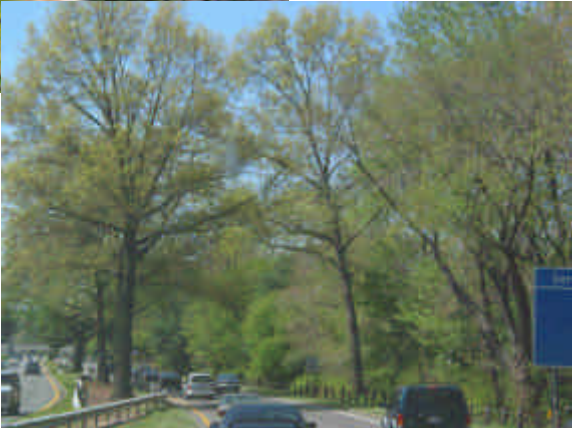
Figure 4: Character and Setting

Over the years, the gardens were transformed to rather dense and overgrown forests, that while different from originally conceived, still provide a peaceful park-like setting (See Figure 4). However, despite the park-like setting, some members of the public indicated during this case study, that they still feel somewhat unsafe on the narrow road that lacks shoulders. Vehicles tend to drive freeway level speeds on this road which lacks interstate level geometric standards. When the redesign process for the parkway began in 1992, the ADT was nearly 40,000 vehicles (no trucks or buses are allowed on the parkway) and the 85% percentile speed was approaching 70 mph.²

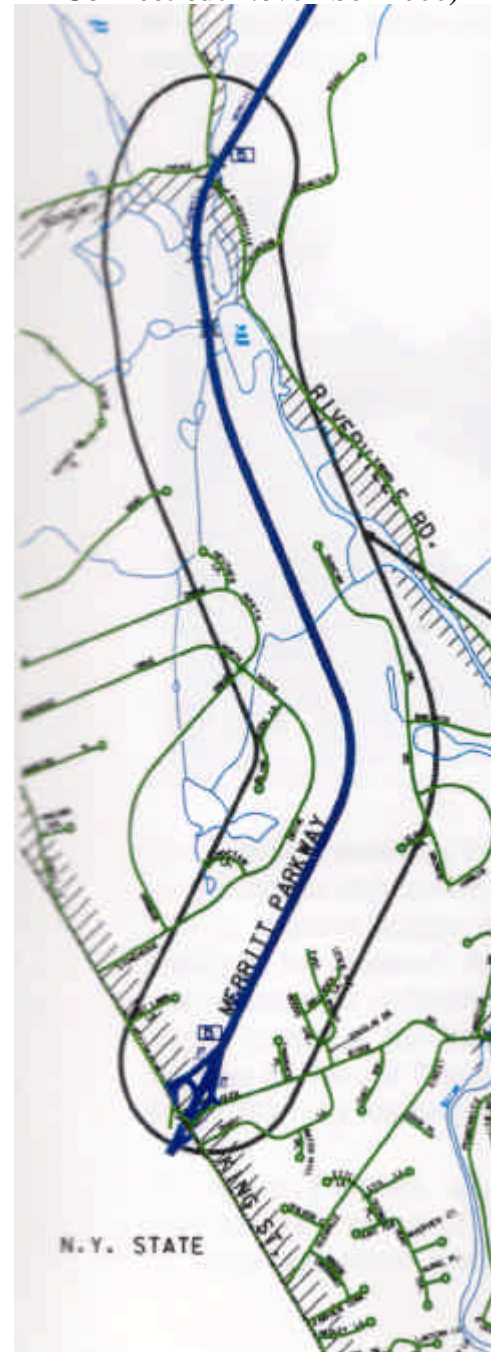
Figure 5: Gateway Section of Merritt Parkway (Source: CSD in Connecticut November 2000)

This case study focuses on the initial context sensitive design process which preceded the first improvements to the highway and revitalization of the setting. This first section runs from the New York State Line in the Town of Greenwich in the southwest corner of Connecticut. The project runs for 2.5 miles. The general location is shown in Figure 1, while the first phase section, known as the Gateway, is shown in Figure 5. The second phase of work is about to start in 2002 and the third phase is in design. These subsequent phases are proceeding based on the documented guidelines and landscape plan that was developed during the multi-year multi-group effort preceding the gateway project.

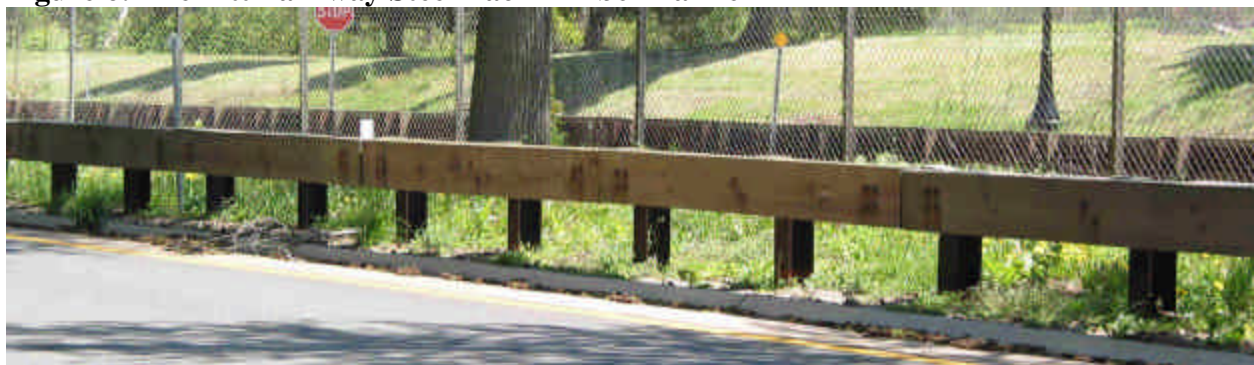
Figure 6: Merritt Parkway Steel Back Timber Barrier

Concerns related to scenery and aesthetics were of interest to all stakeholders. Of particular interest in this case was the development of a rigid barrier system that fit with the scenery of the parkway but also provided protection to drivers along the median and shoulders of the road. The very small median and the presence of trees in the median were of concern. Along the shoulder and clear zone, both rocks and trees were of concern. After reviewing existing systems, the DOT designed and tested its own steel-back timber barrier system (Figure 6). Several iterations were needed with crash testing before a final acceptable design was selected.

The final project can be considered a successful compromise. The parkway remains a beautiful roadway with spectacular bridges. However, traffic congestion in the overall southwest corridor of Connecticut is still significant. Although guard rails and other improvements should show success in improving crash or fatality rates on the Merritt Parkway, speeds remain high and the facility lacks what might be considered less than the highest levels of safe engineering design. The wood guardrail has been hailed as a great success. Groups are working together to improve
